# Manhole Inspection Summary

Manhole # S47K\_\_005MH

**Inspection** ☐ Is Incomplete Rating: **5) Immediate Attention Required**

**Location** Address: **2227 essex st**

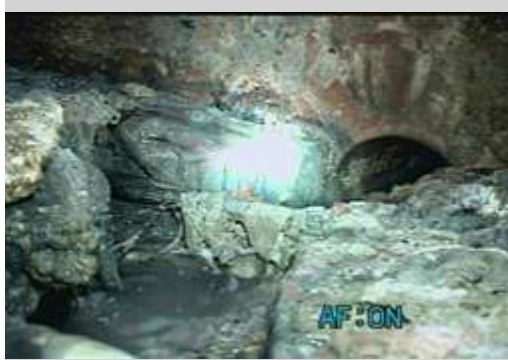
Defect 4

Condition: ☐ Sound ☐ Cracked ☐ Root Intrusion ☐ Deteriorated ☐ Leaks ☒ **Debris**

channel debris

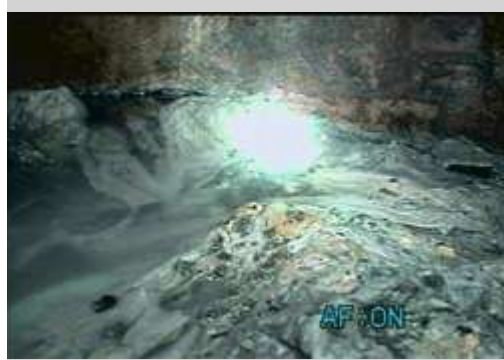
Defect 3

Condition: ☐ Sound ☐ Cracked ☐ Root Intrusion ☐ Deteriorated ☐ Leaks ☒ **Debris**

bench debris

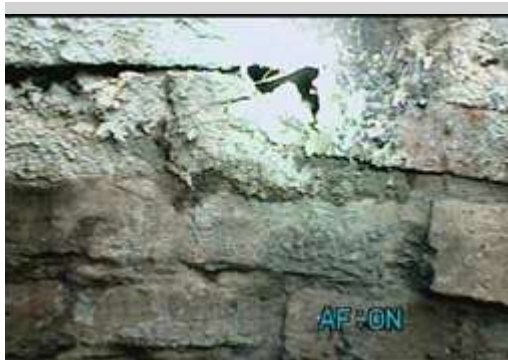
Defect 2

Condition: ☐ Sound ☐ Cracked ☐ Root Intrusion ☐ Loose Brick ☒ **Deteriorated**

chimney deteriorated, frame adj

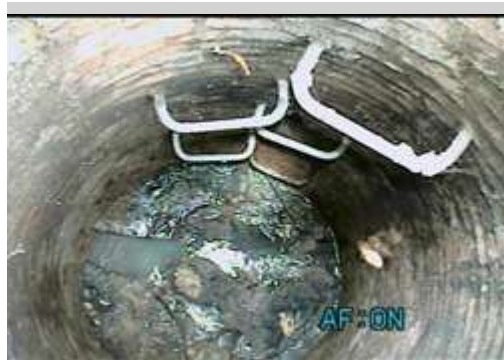
Defect 1

Condition: ☐ Sound ☐ Cracked ☐ Root Intrusion ☐ Loose Brick ☒ **Deteriorated**

Count: **5** Missing: **0** ☒ **Corroded**

corroded steps, barrel deteriorated

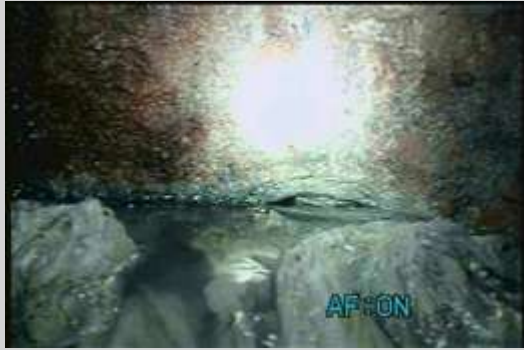
9 O'Clock Inflow

can only see top of pipe rest is under water
